Galvanic Corrosion Research

FINAL REPORT

GALVANIC CORROSION

COMMUNICATION EQUIPMENTS

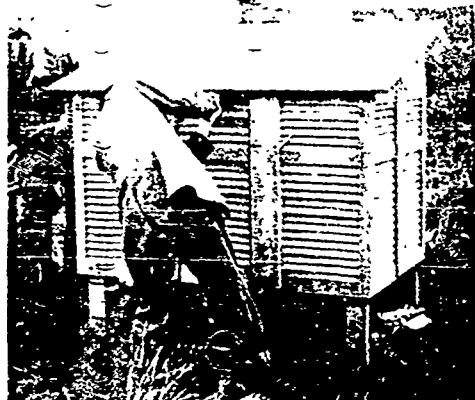
SHELTER INSTALLED AT POINT REYES
